# CAUNTON AVE. FLATS

# A REPORT BY C.A.F.T.A.

## Caunton Ave Flat/Maisonette Complex, Nottingham

## Report on Dampness at the Cauntton Avenue Estate, Mapperley

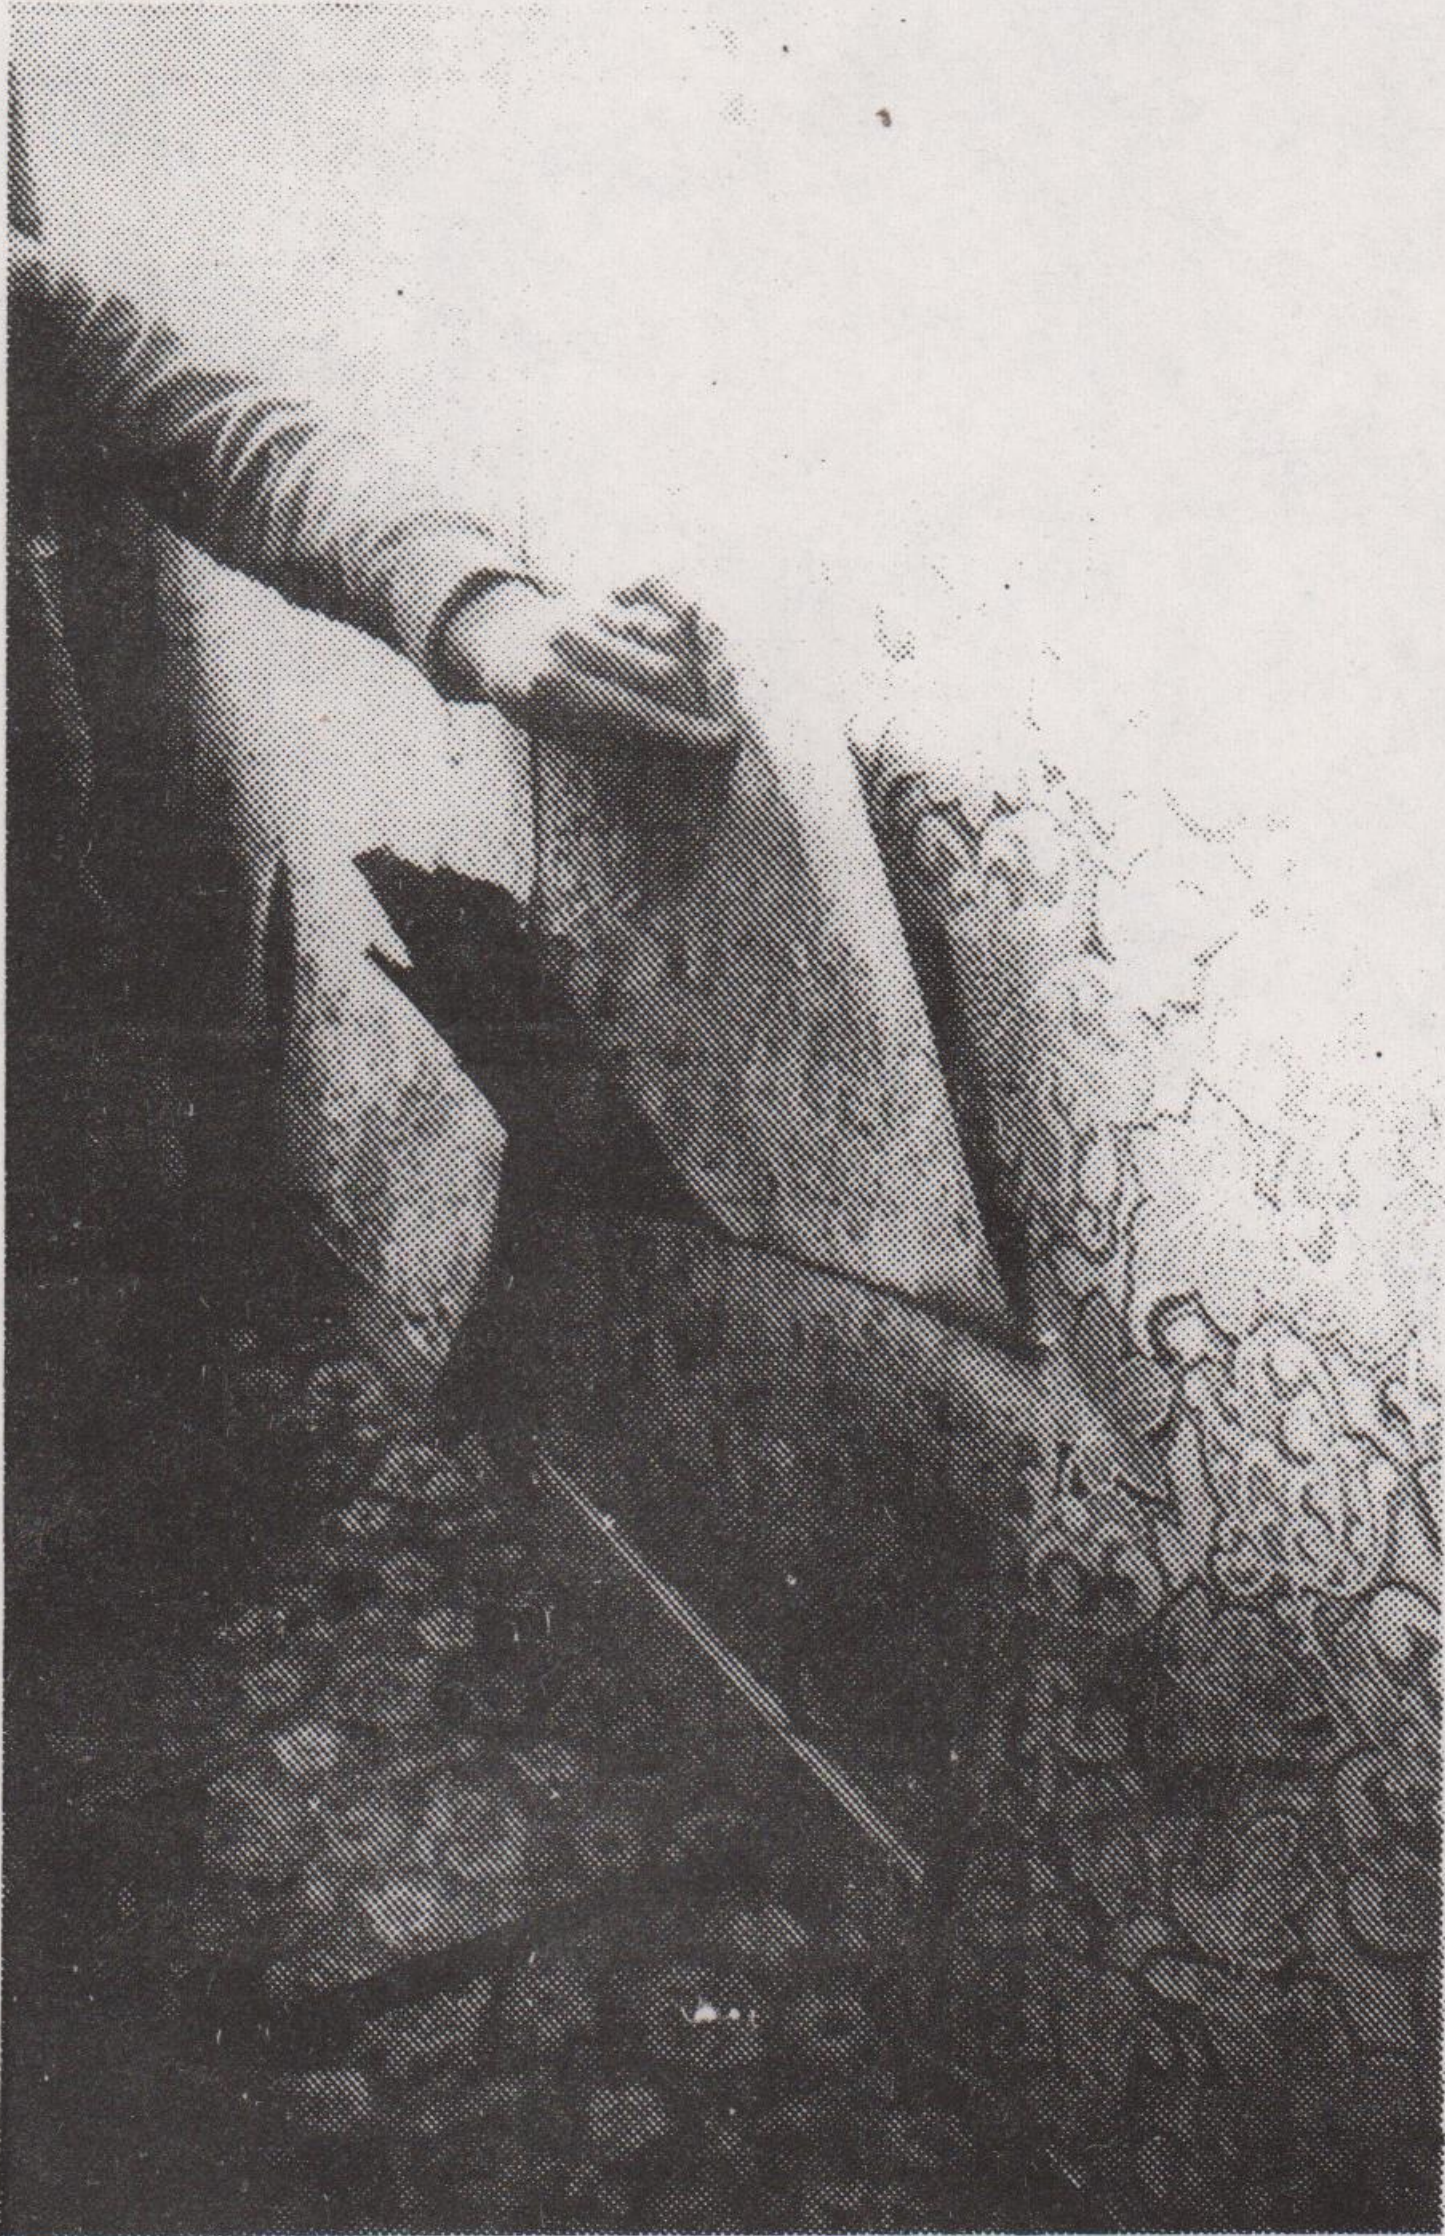
Rising Damp.

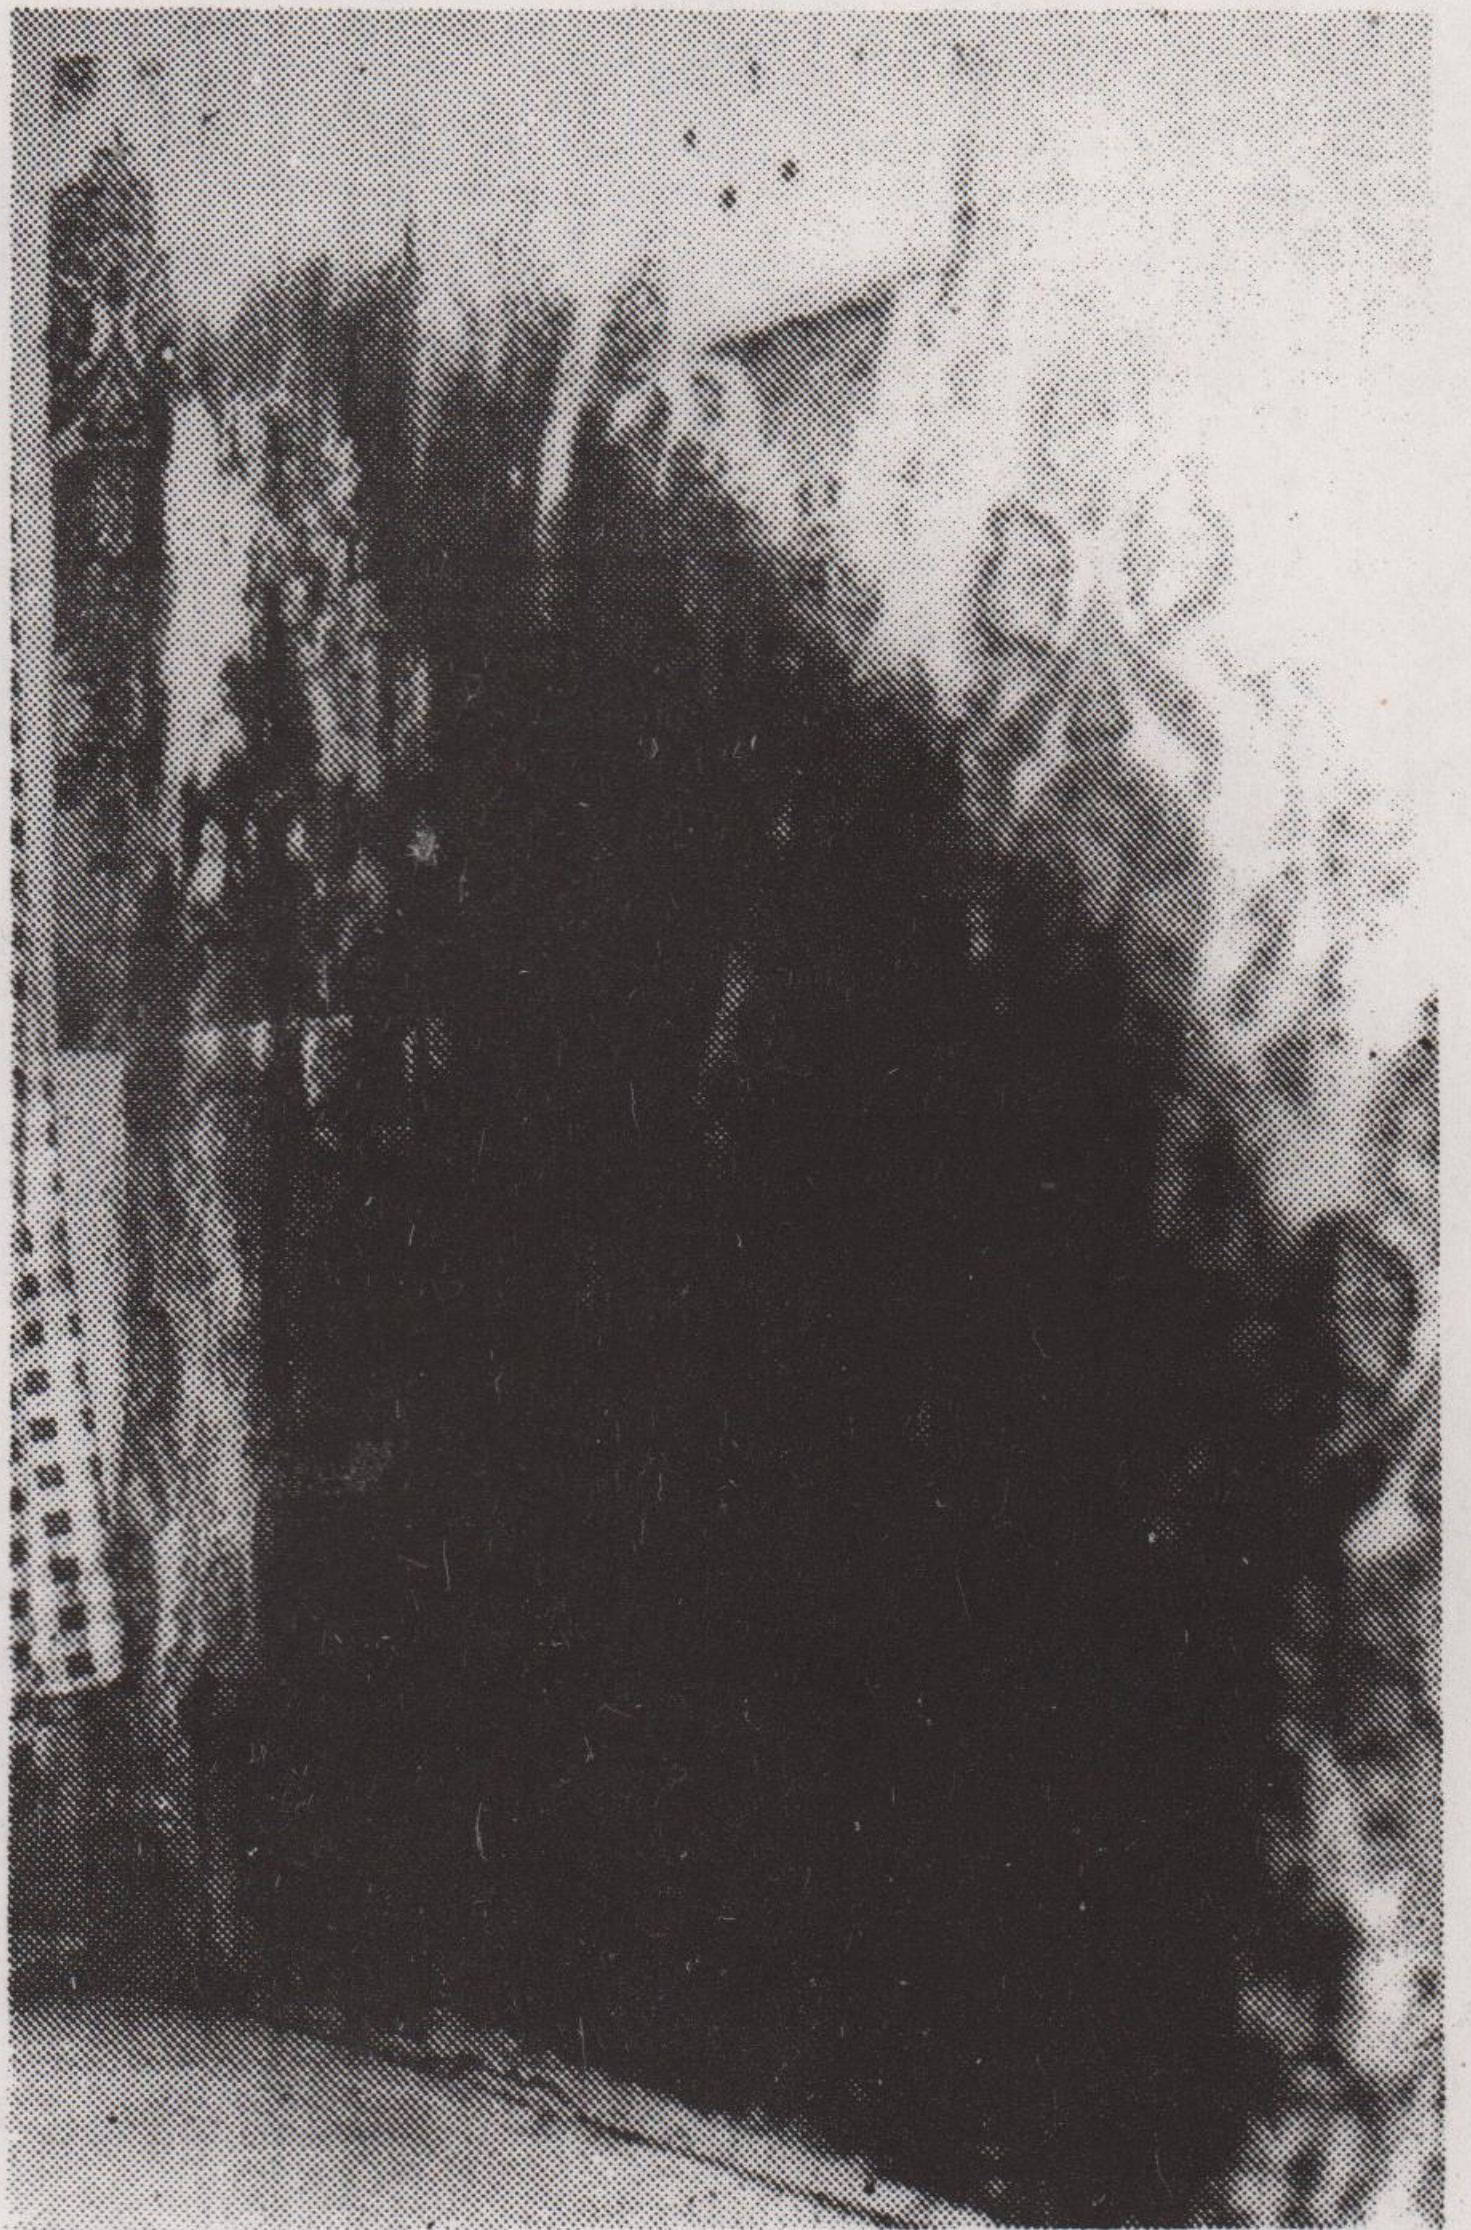
Condensation.

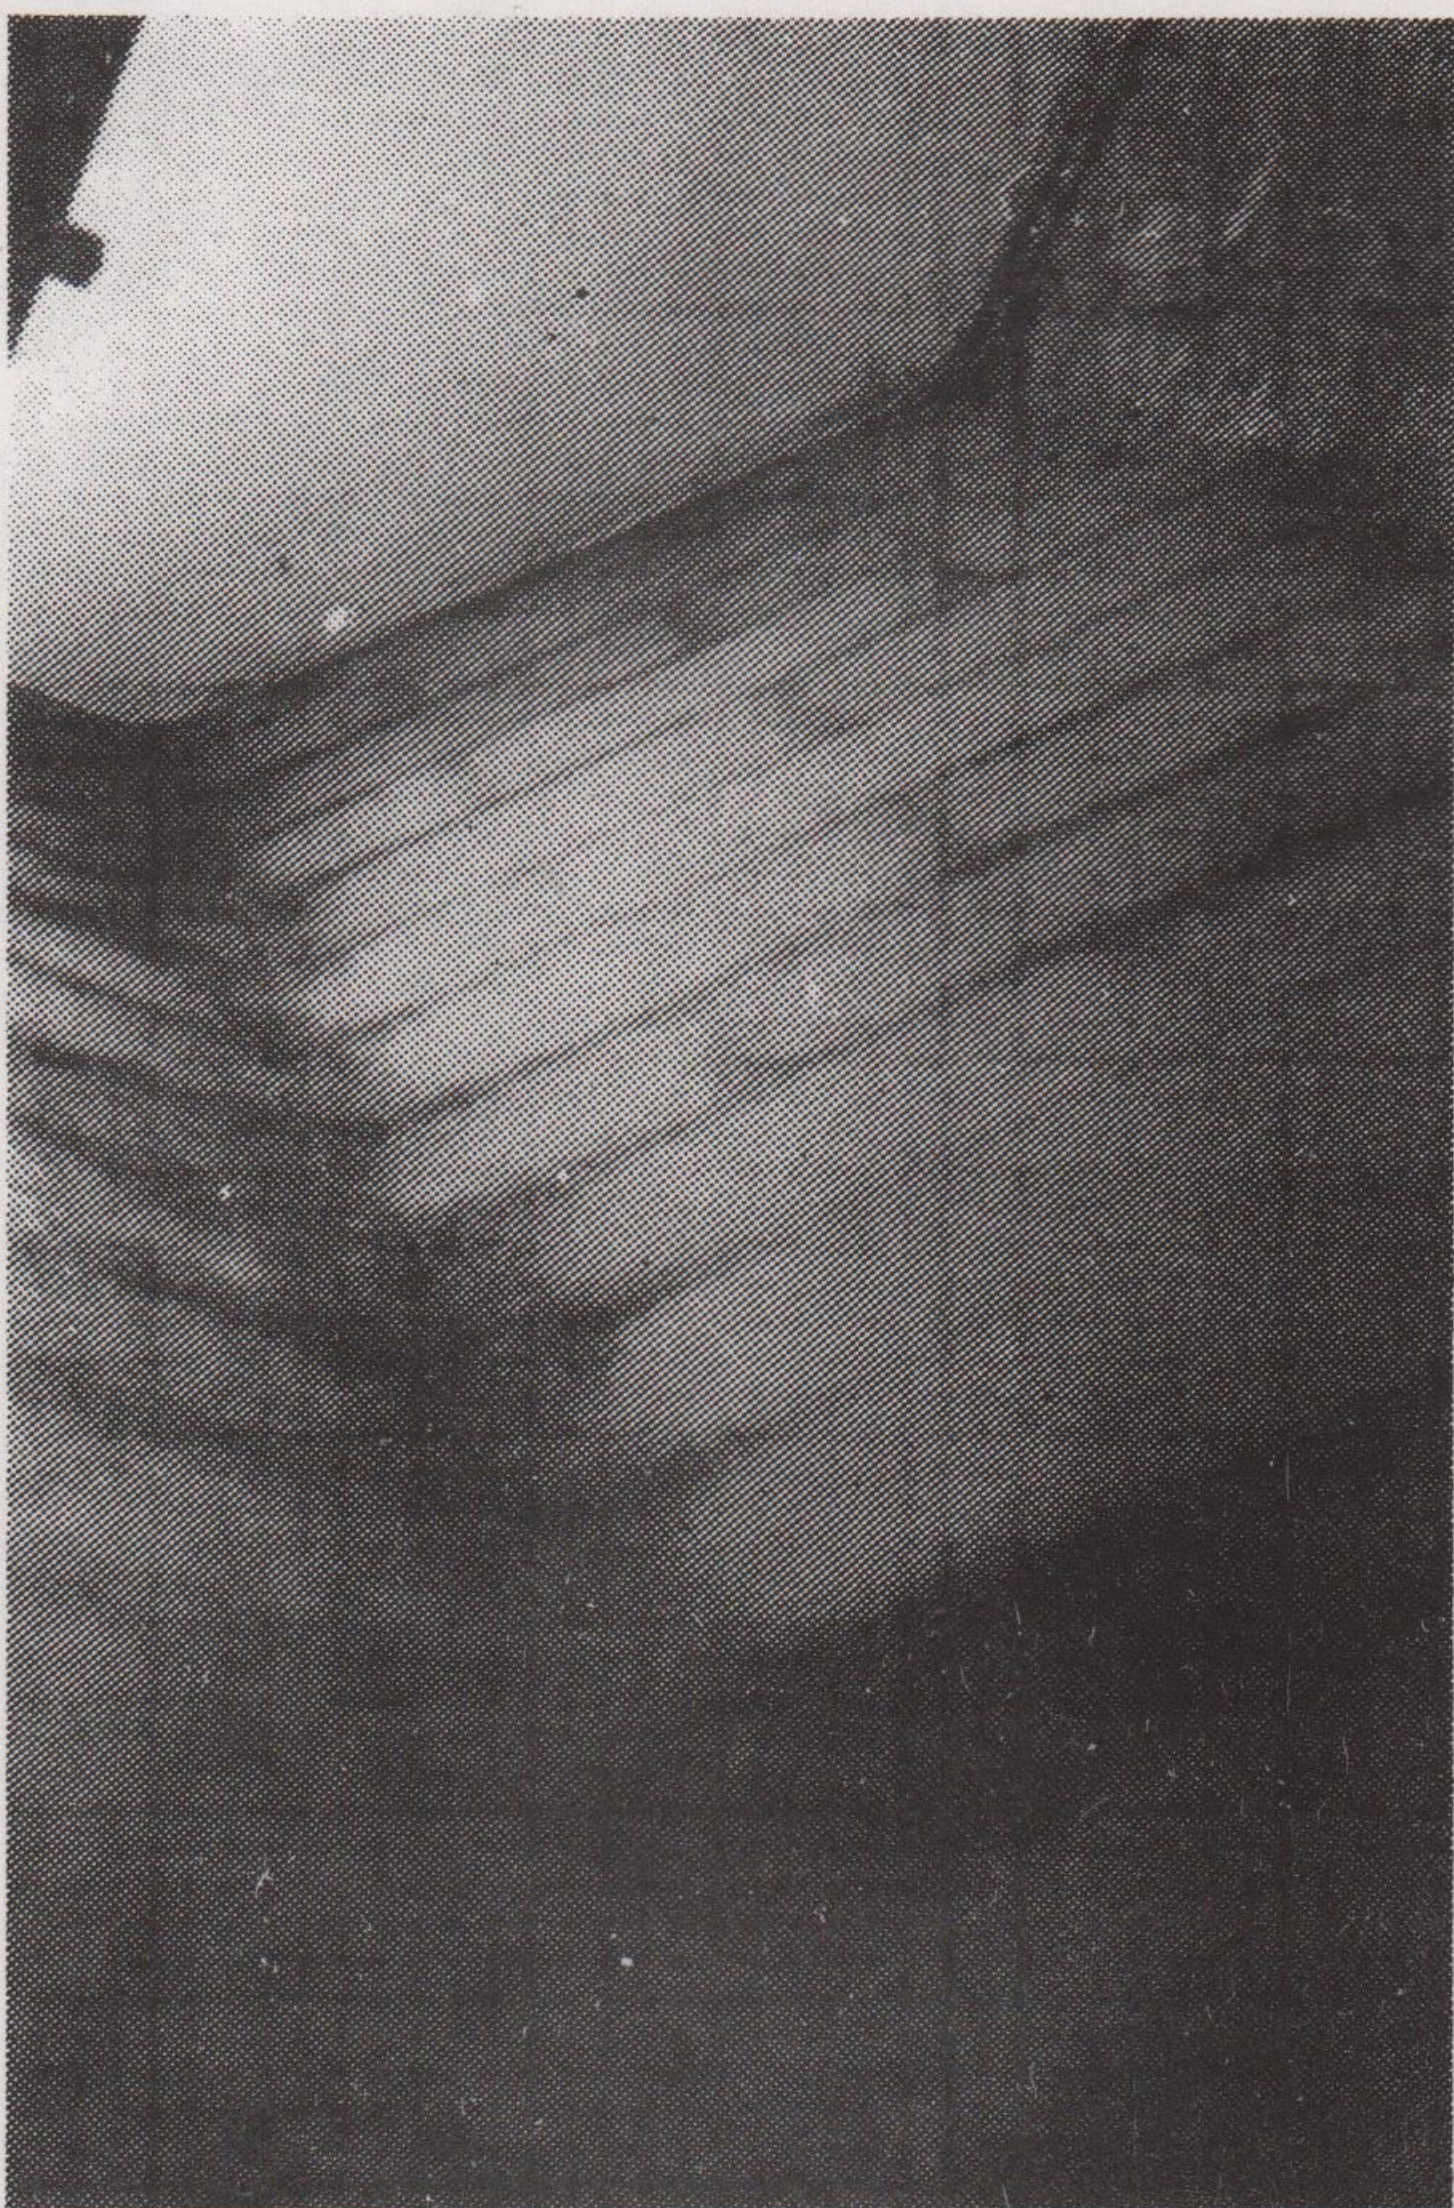
Water Penetration Through Walls.

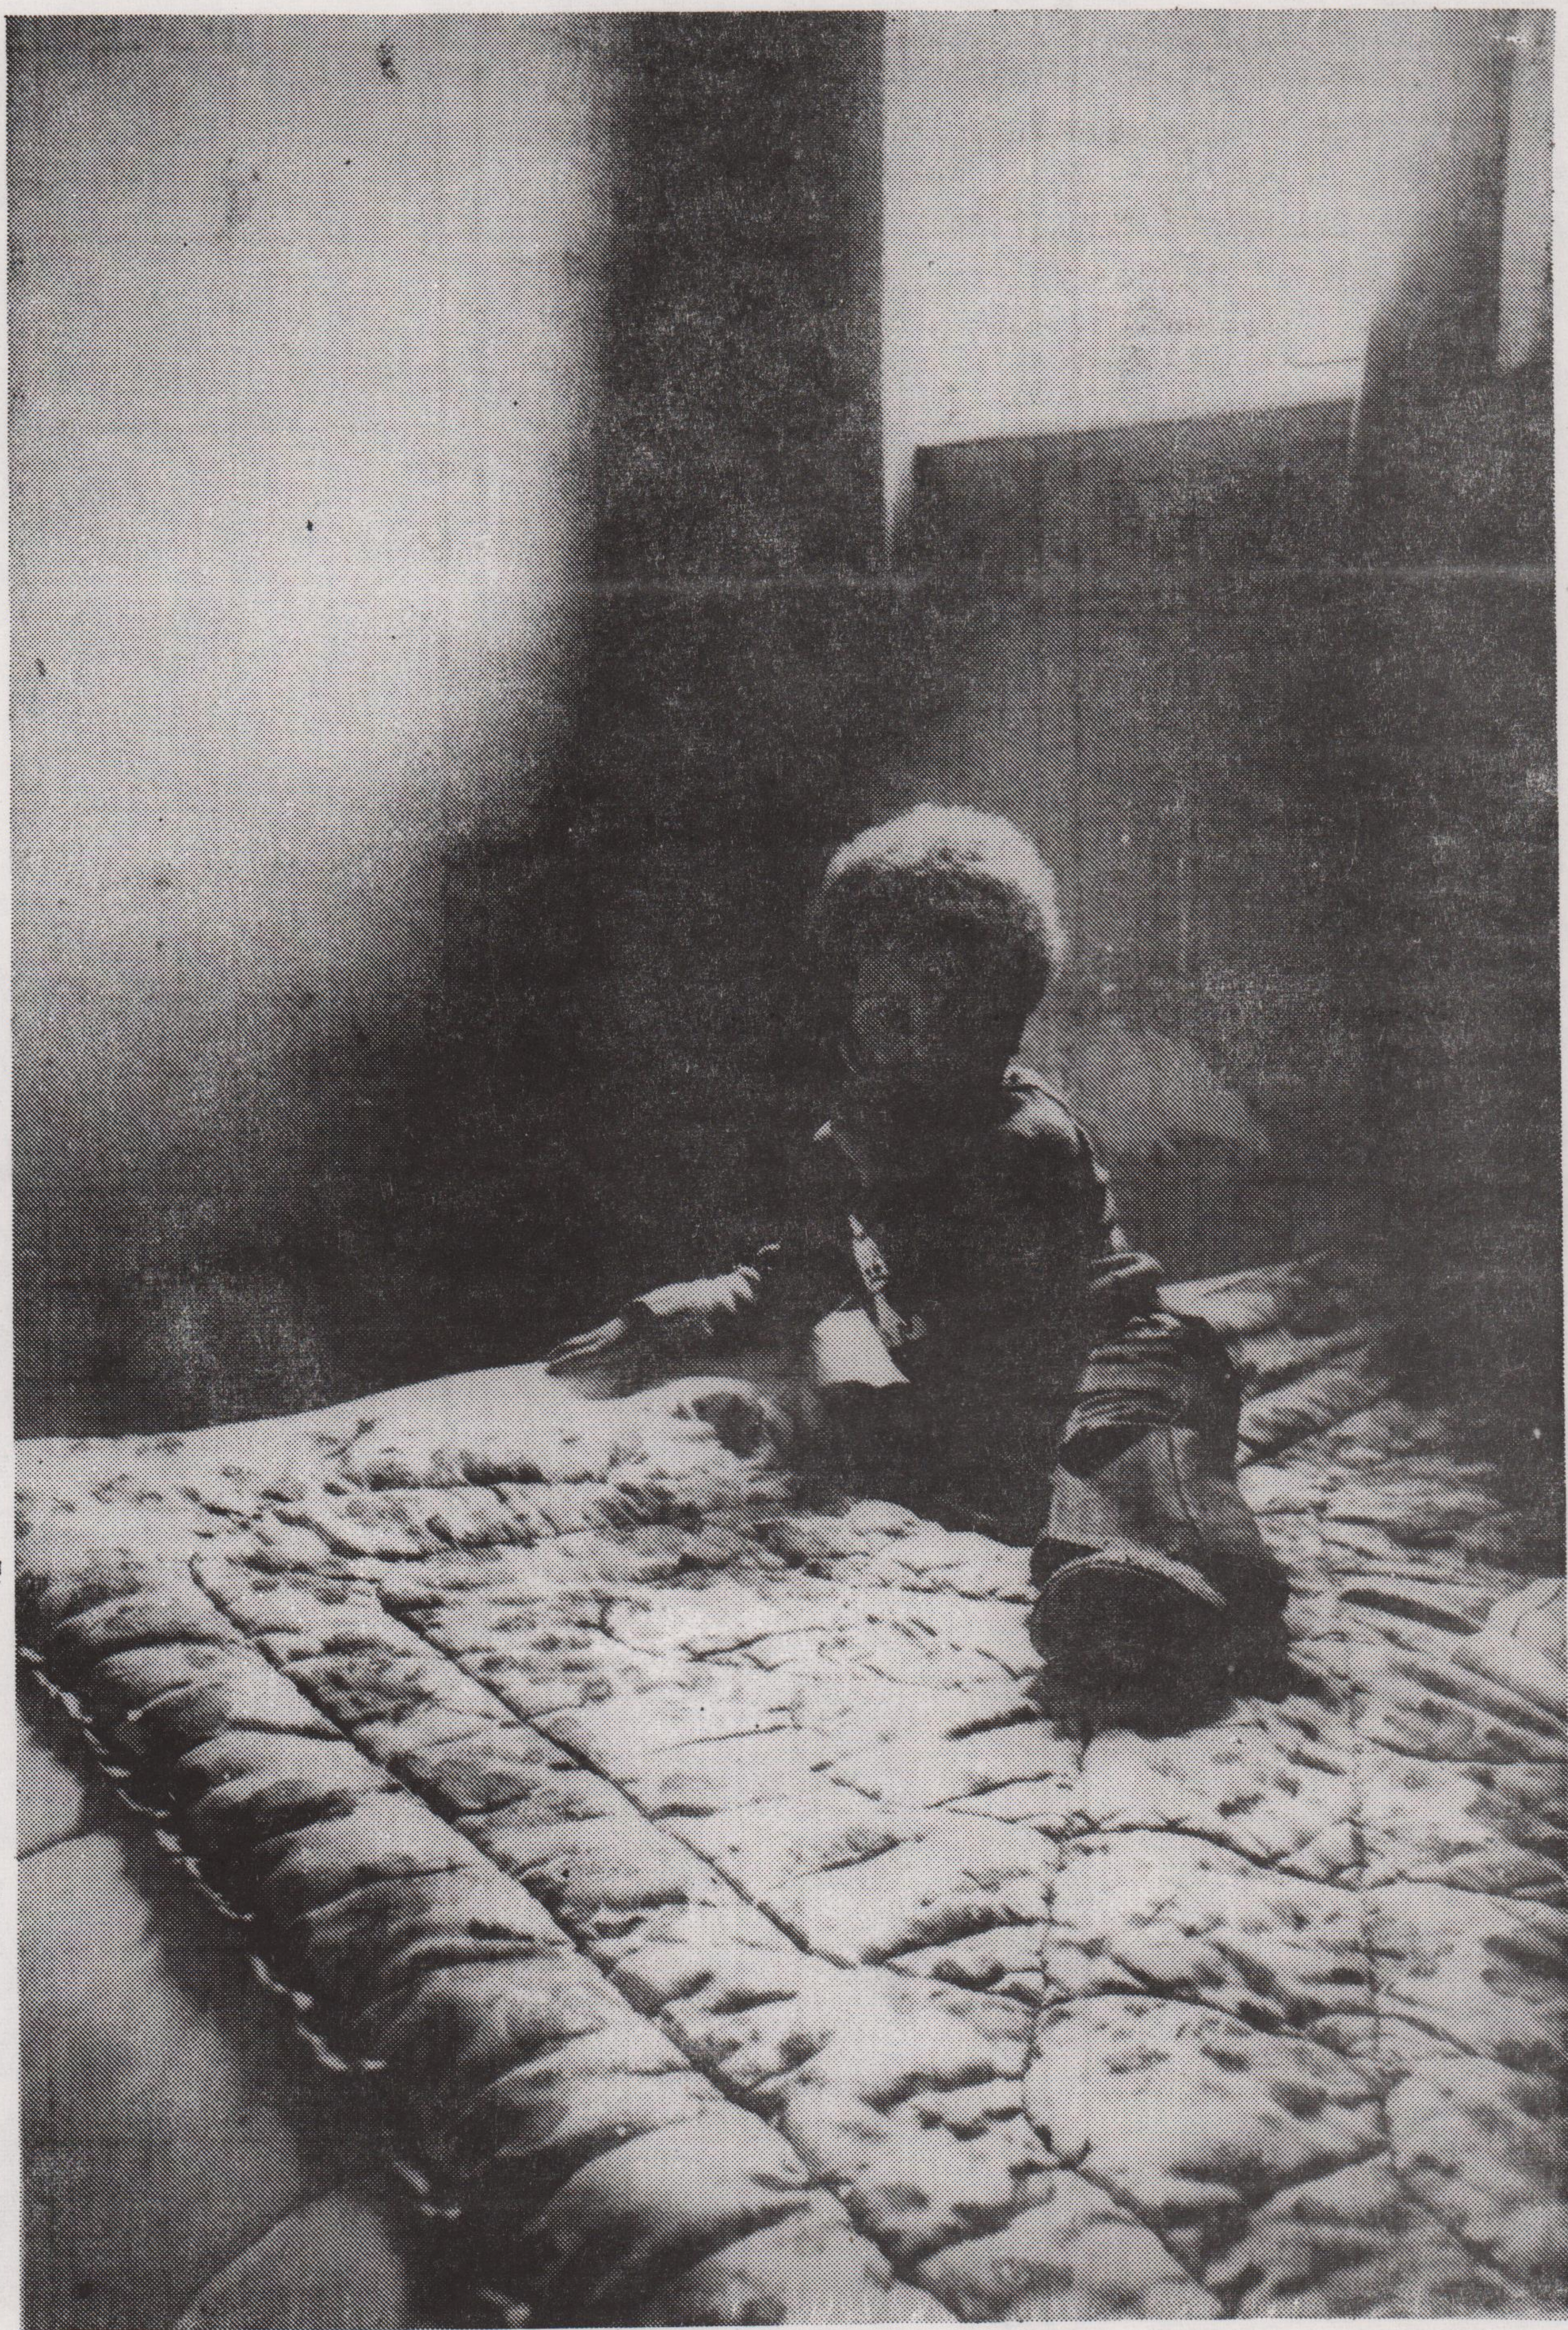
A Toddlers Bedroom With Water Entering Through Walls  
and Ceilings.

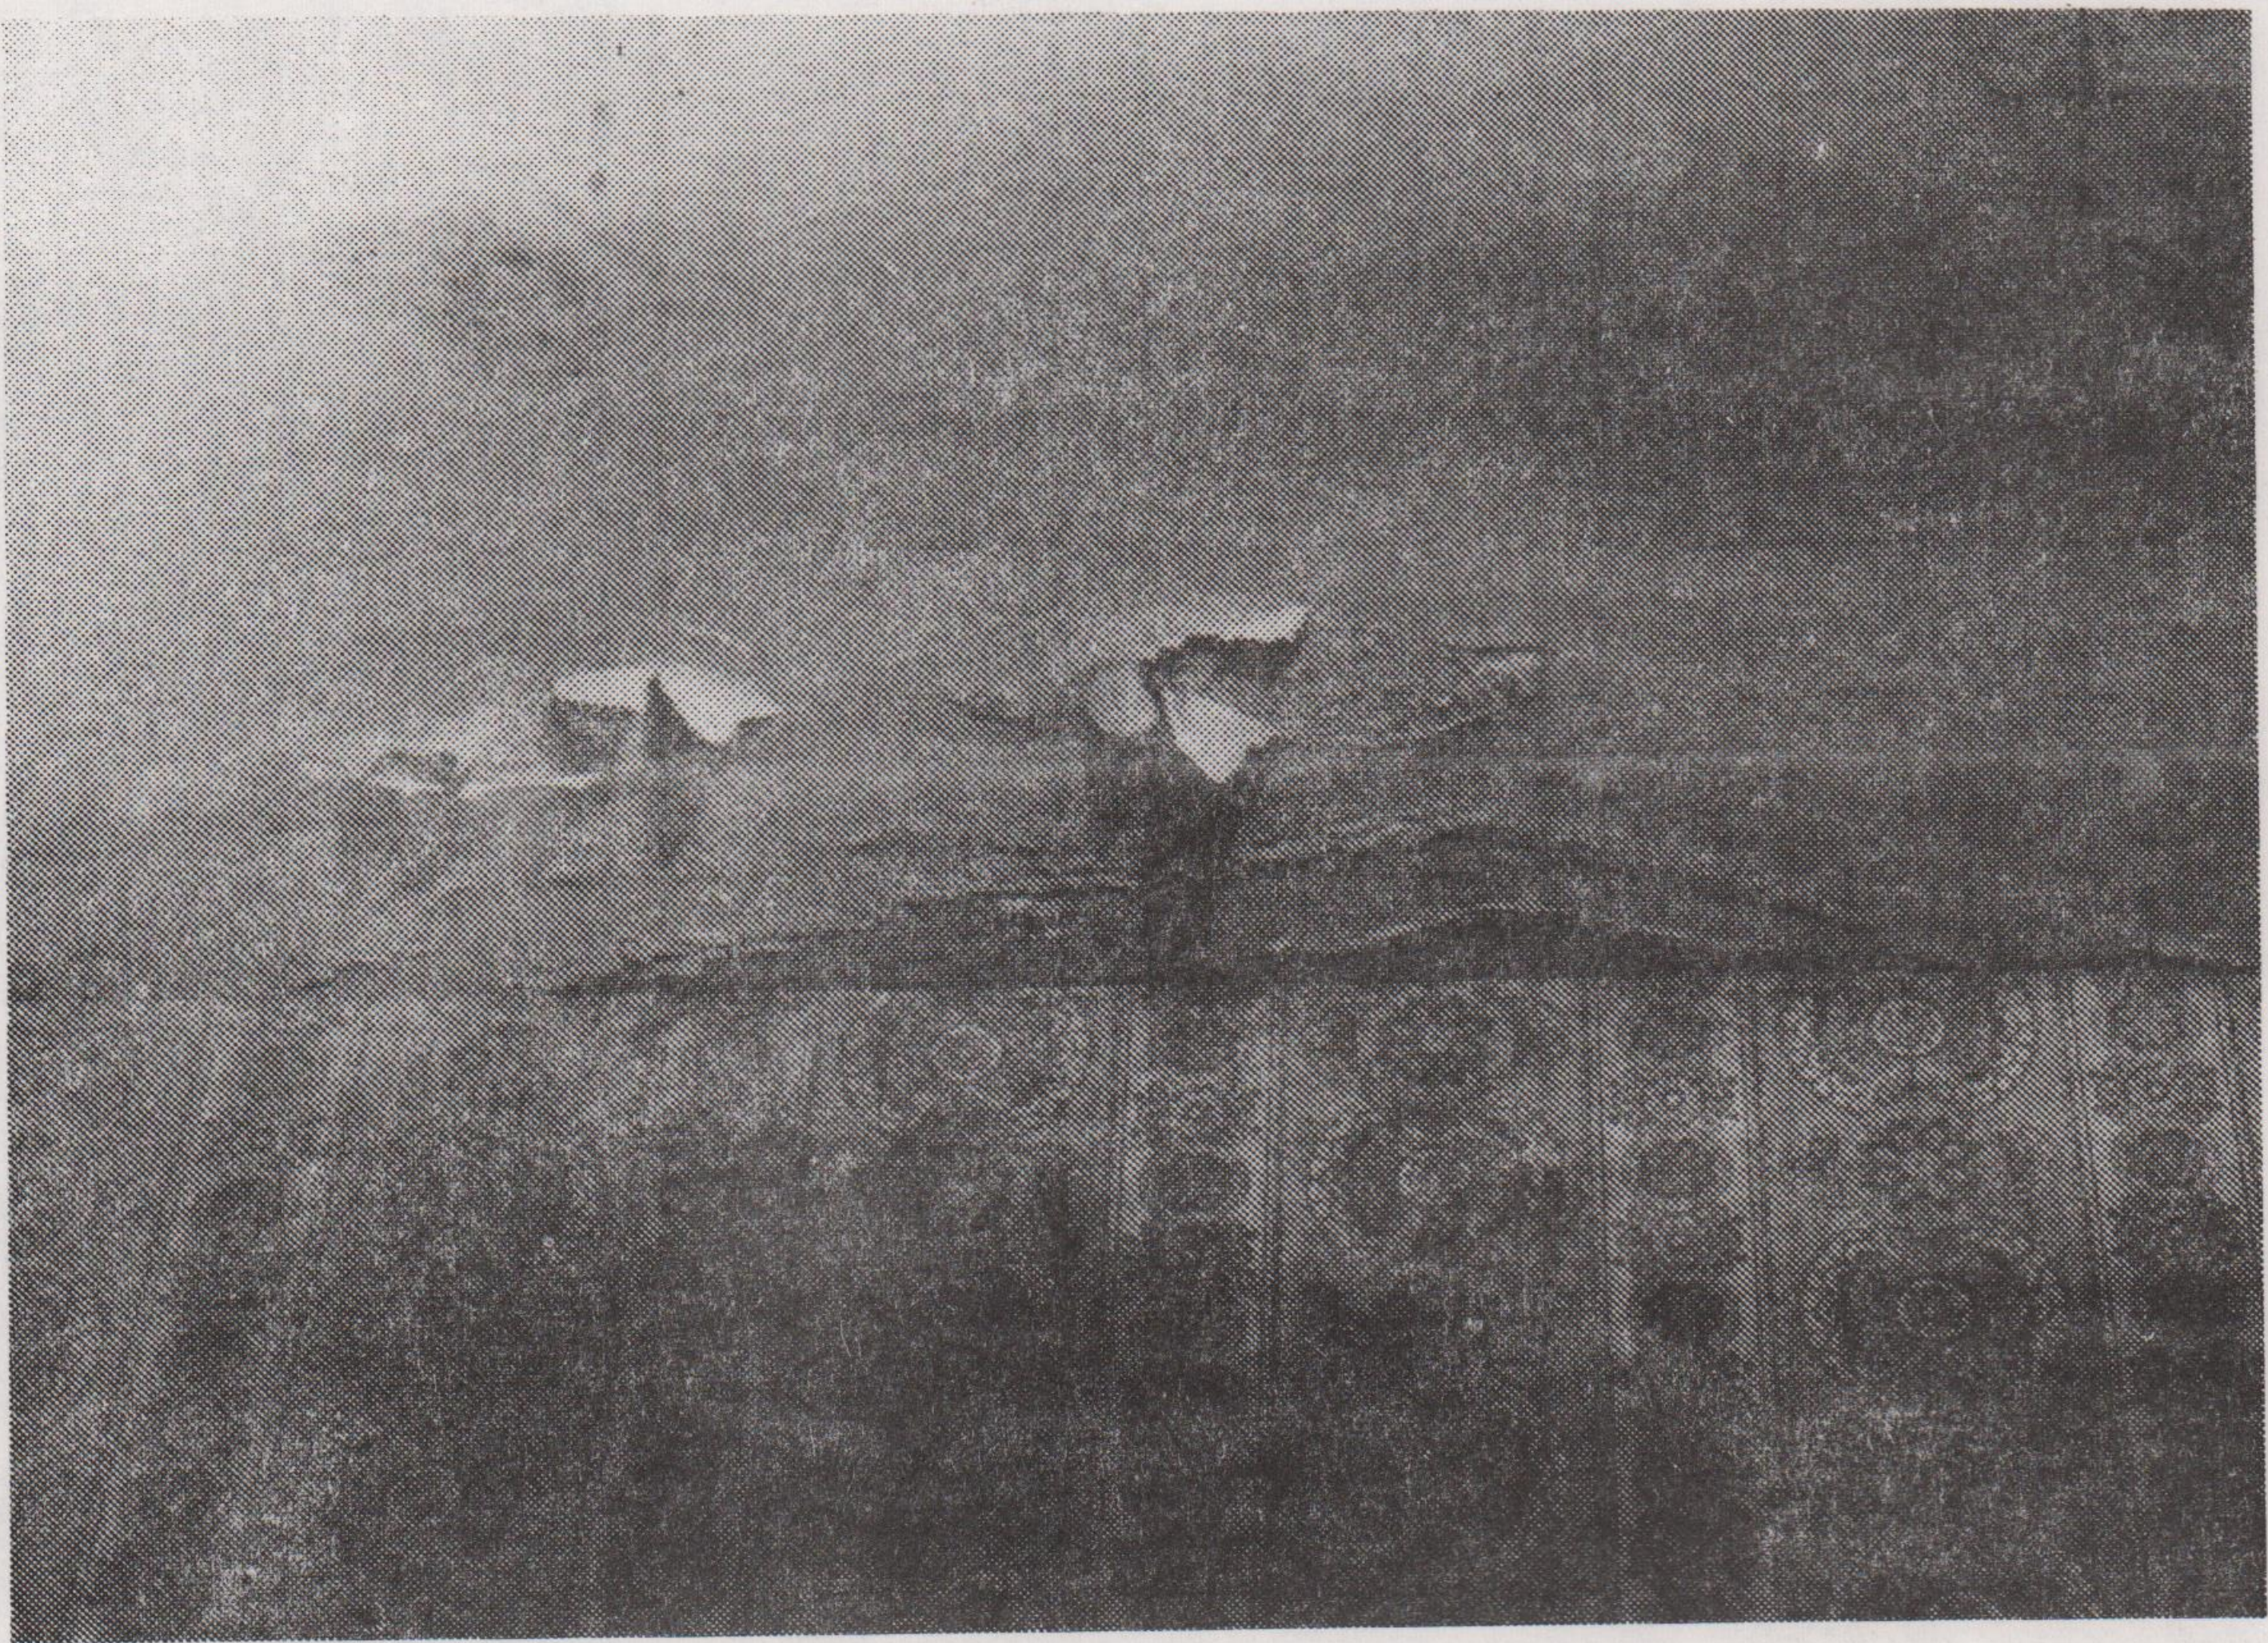
Living With Defective Roofs.

Problem : Ingress of moisture into the dwellings probably caused by damage to the built-up roofing at the verge detail around the roof perimeter or at the numerous penetrations through the roof by vent and ventilation extract pipes, resulting from general settlement of the structure.

The most satisfactory answer would be to completely strip off the chippings and the built-up roofing, renew any insulation as necessary and relay the following water proofing,

Specification: One base layer of perforated bitumen glass fibre venting felt, such as "Rubervent", followed by one layer of bitumen glass fibre felt type 3B to BS747, ie "Glasphalt", with a capping layer of bitumen heavy duty polyester base felt, ie "Ruberfort", all bonded together in hot bitumen.

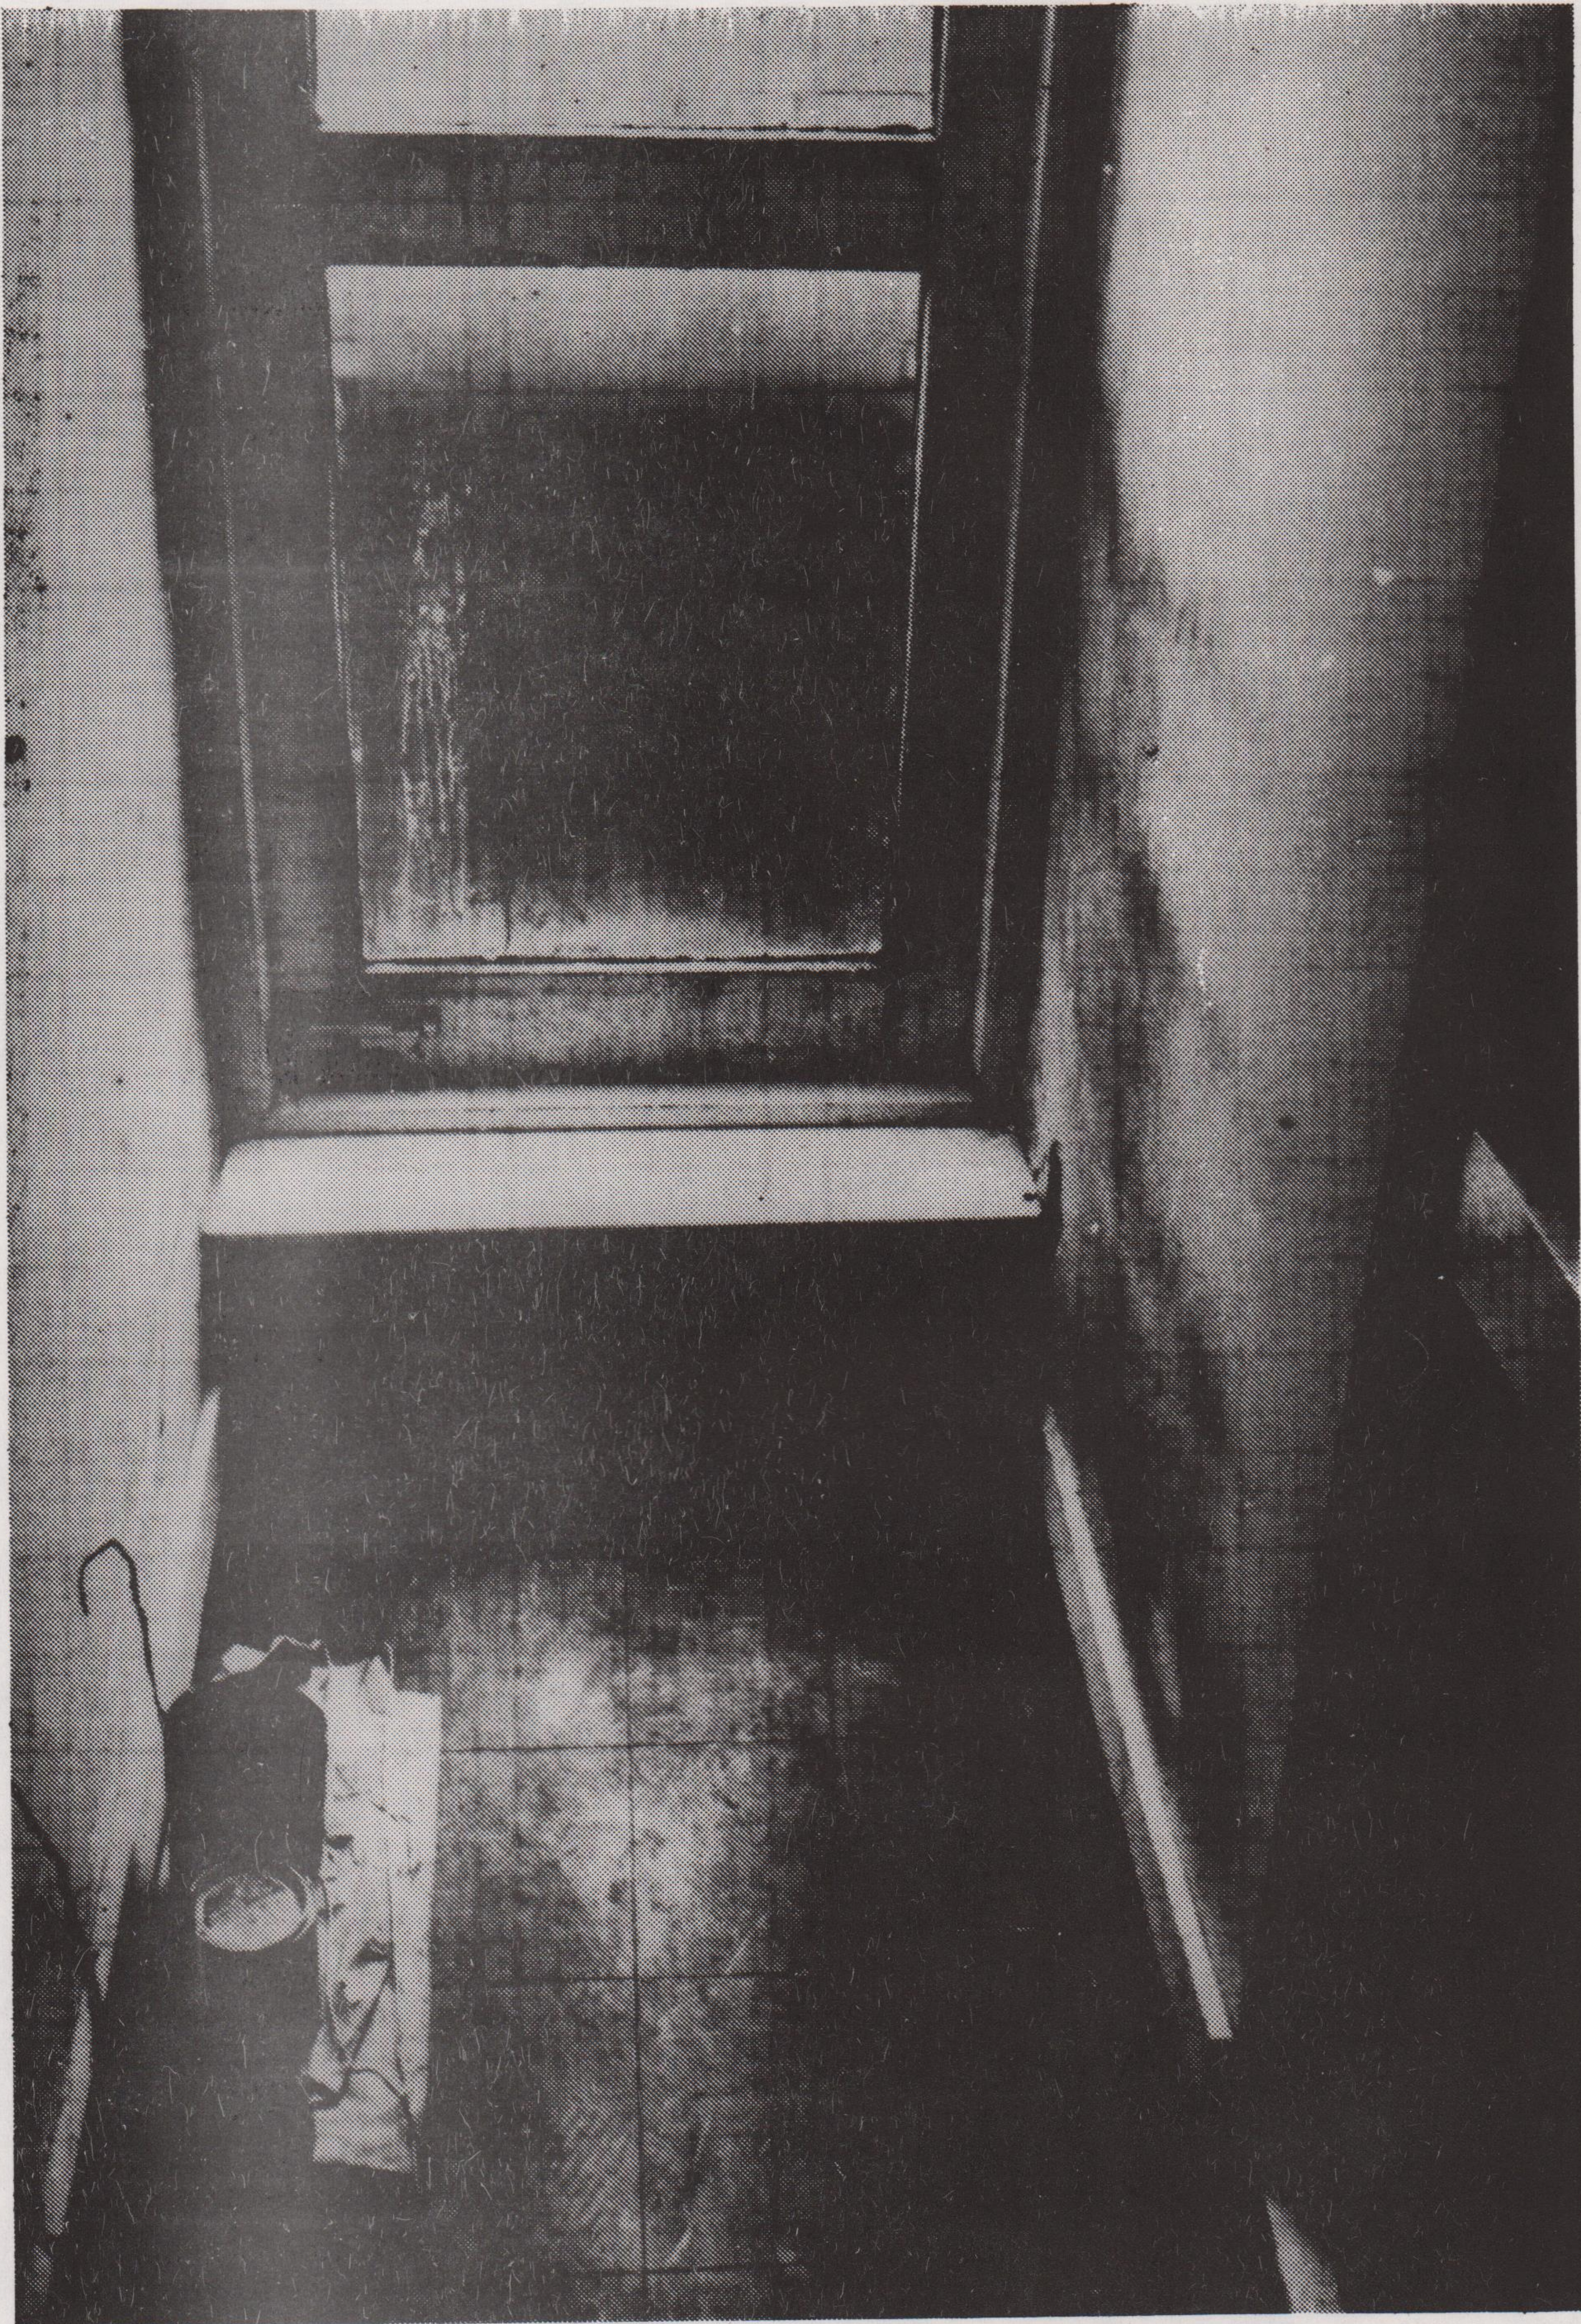
Badly Fitting Doors and Windows Let In More Damp.
